GENESIS CONCENTRATOR TARGET PARTICLE CONTAMINATION MAPPING AND MATERIAL IDENTIFICATION. M.J. Calaway¹, M.C. Rodriguez², and J.H. Allton³: (1) Jacobs (ESCG) at NASA Johnson Space Center, Houston, TX; (2) Geocontrol Systems (ESCG) at NASA Johnson Space Center, Houston, TX; (3) NASA, Johnson Space Center, Houston, TX; michael.calaway-1@nasa.gov.

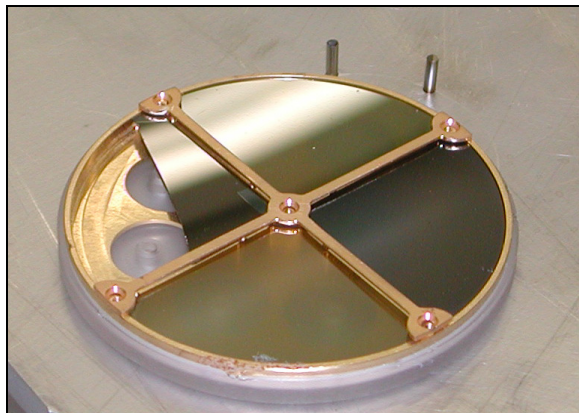
Fig. 1: Genesis Concentrator Target after Landing. In the above image, SiC target quadrants are on the top and bottom (60001 and 60003 respectively). The CVD target (60002) is on the right and the partial DOS target fragment is on the left.

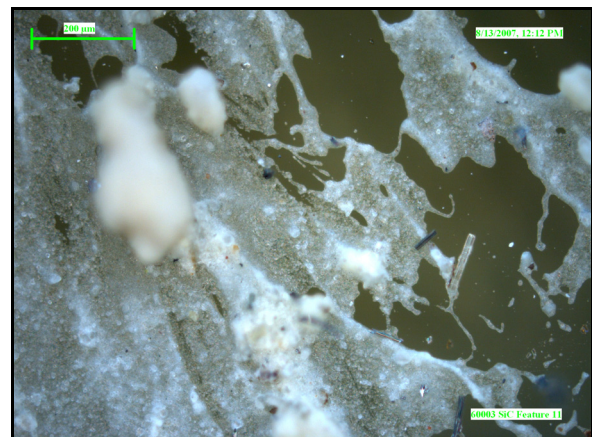
originating from the crash environment were imaged with a Leica DM6000M automated microscope using 5X, 10X, and 50X objective lens. Feature locations were then mapped to an overview mosaic image. Figure 2 shows an image example of a salt deposit on SiC target 60003. The salt deposit is probably a dried mixture of halite and other sediments from the lacustrine environment at the Utah Test and Training Range. Black carbon-carbon fibers, Al fragments, and other SRC materials can be visibly identified mixed within the salt matrix. Figure 3 shows an example of microsphere contamination most likely from the super-light ablator (SLA) material from the SRC.

Fig. 2: SiC 60003 salt feature using a 10X objective lens. Scale bar is 200 μm.

Chemical cleaning techniques with Xylene and HF in an ultrasonic bath are currently being investigated for removal of small particles by the Genesis science team as well as ultra-pure water megasonic cleaning by the JSC team [4]. Removal of organic contamination from target materials is also being investigated by the science team with the use of UV-ozone cleaning devices at JSC and Open University [5].

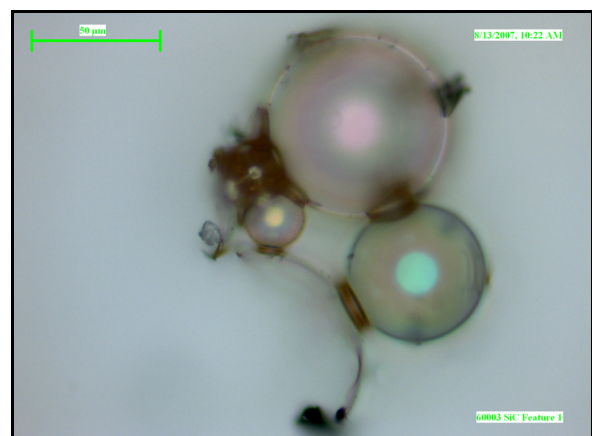
Fig. 3: SiC 60003 microsphere feature at 50X objective lens. Scale bar is 50 μm.

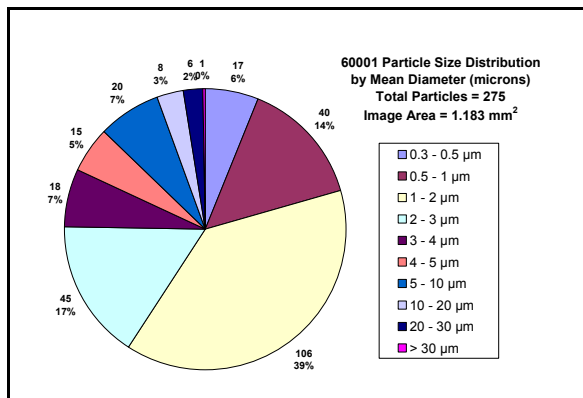
Fig. 4: SiC 60001 above target graph shows that 88% of the particles are $< 5 \mu\text{m}$ in diameter and 59% are $< 2 \mu\text{m}$ in diameter.

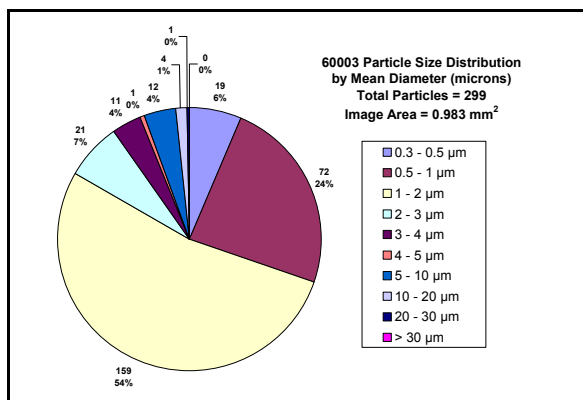
Fig. 5: SiC 60003 above target graph shows that 95% of the particles are $< 5 \mu\text{m}$ in diameter and 84% are $< 2 \mu\text{m}$ in diameter.

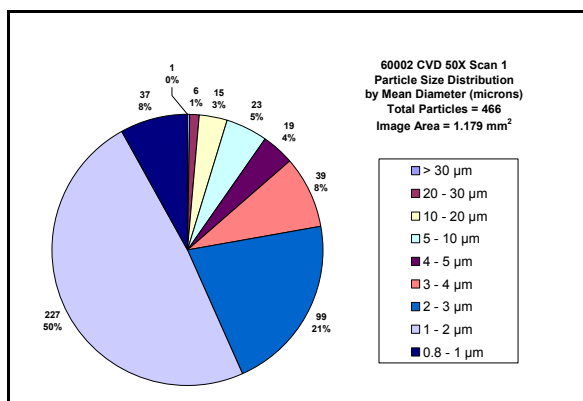
Fig. 6: CVD 60002 above target graph shows that 91% of the particles are $< 5 \mu\text{m}$ in diameter and 58% are $< 2 \mu\text{m}$ in diameter.

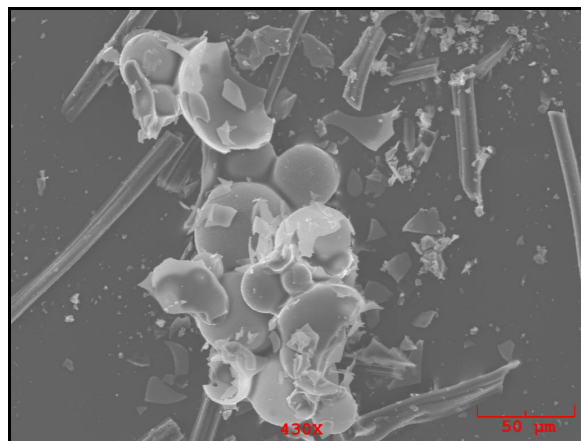
SEM Imaging and EDS Analysis: Since the flown targets could not be examined in a SEM due to instrument induced contamination, EDS analysis of surface particle contamination from the flown acceleration grid was studied and compared with particles on the flown targets. Figure 7 shows a backscatter image of microsphere fragments probably from the SLA material on the SRC.

Fig. 7: SEM image of microsphere particle contamination as well as long carbon fibers on the acceleration grid. Scale bar is $50 \mu\text{m}$.
